Avalanche Details: [Cracking drift in Bridgers](#)

Bridger Range, 2020-12-12

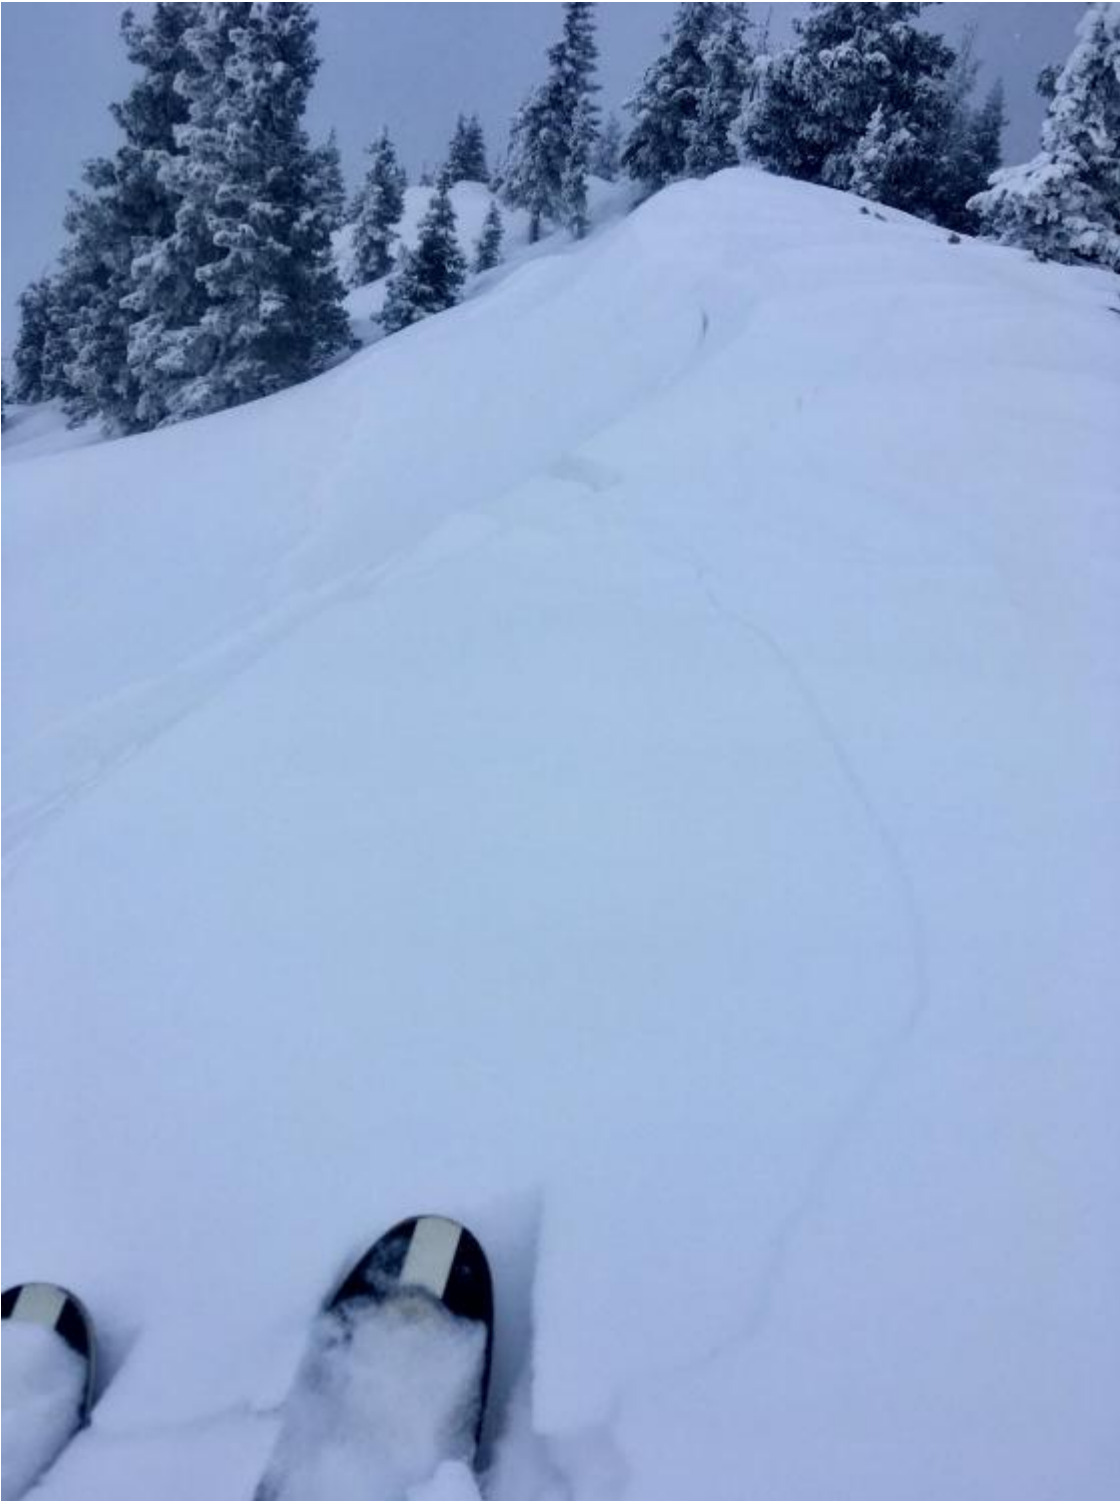
Light wind created soft drifts of new, low density snow near the ridgeline in the Bridger Range. This wind slab easily cracked when touched with skis, 20 feet along the ridge and 5-10 feet down, but didn't slide. This is a sign drifts will be unstable as they grow with more snow and wind. Photo: GNFAAC
