Advisory Region Bridger Range Longitude -110.94W Latitude 45.79N **Avalanche Details:** <u>Many natural avalanches on Saddle Peak</u> **Forecast link:** <u>GNFAC Avalanche Forecast for Tue Dec 17, 2024</u> Bridger Range, 2024-12-16

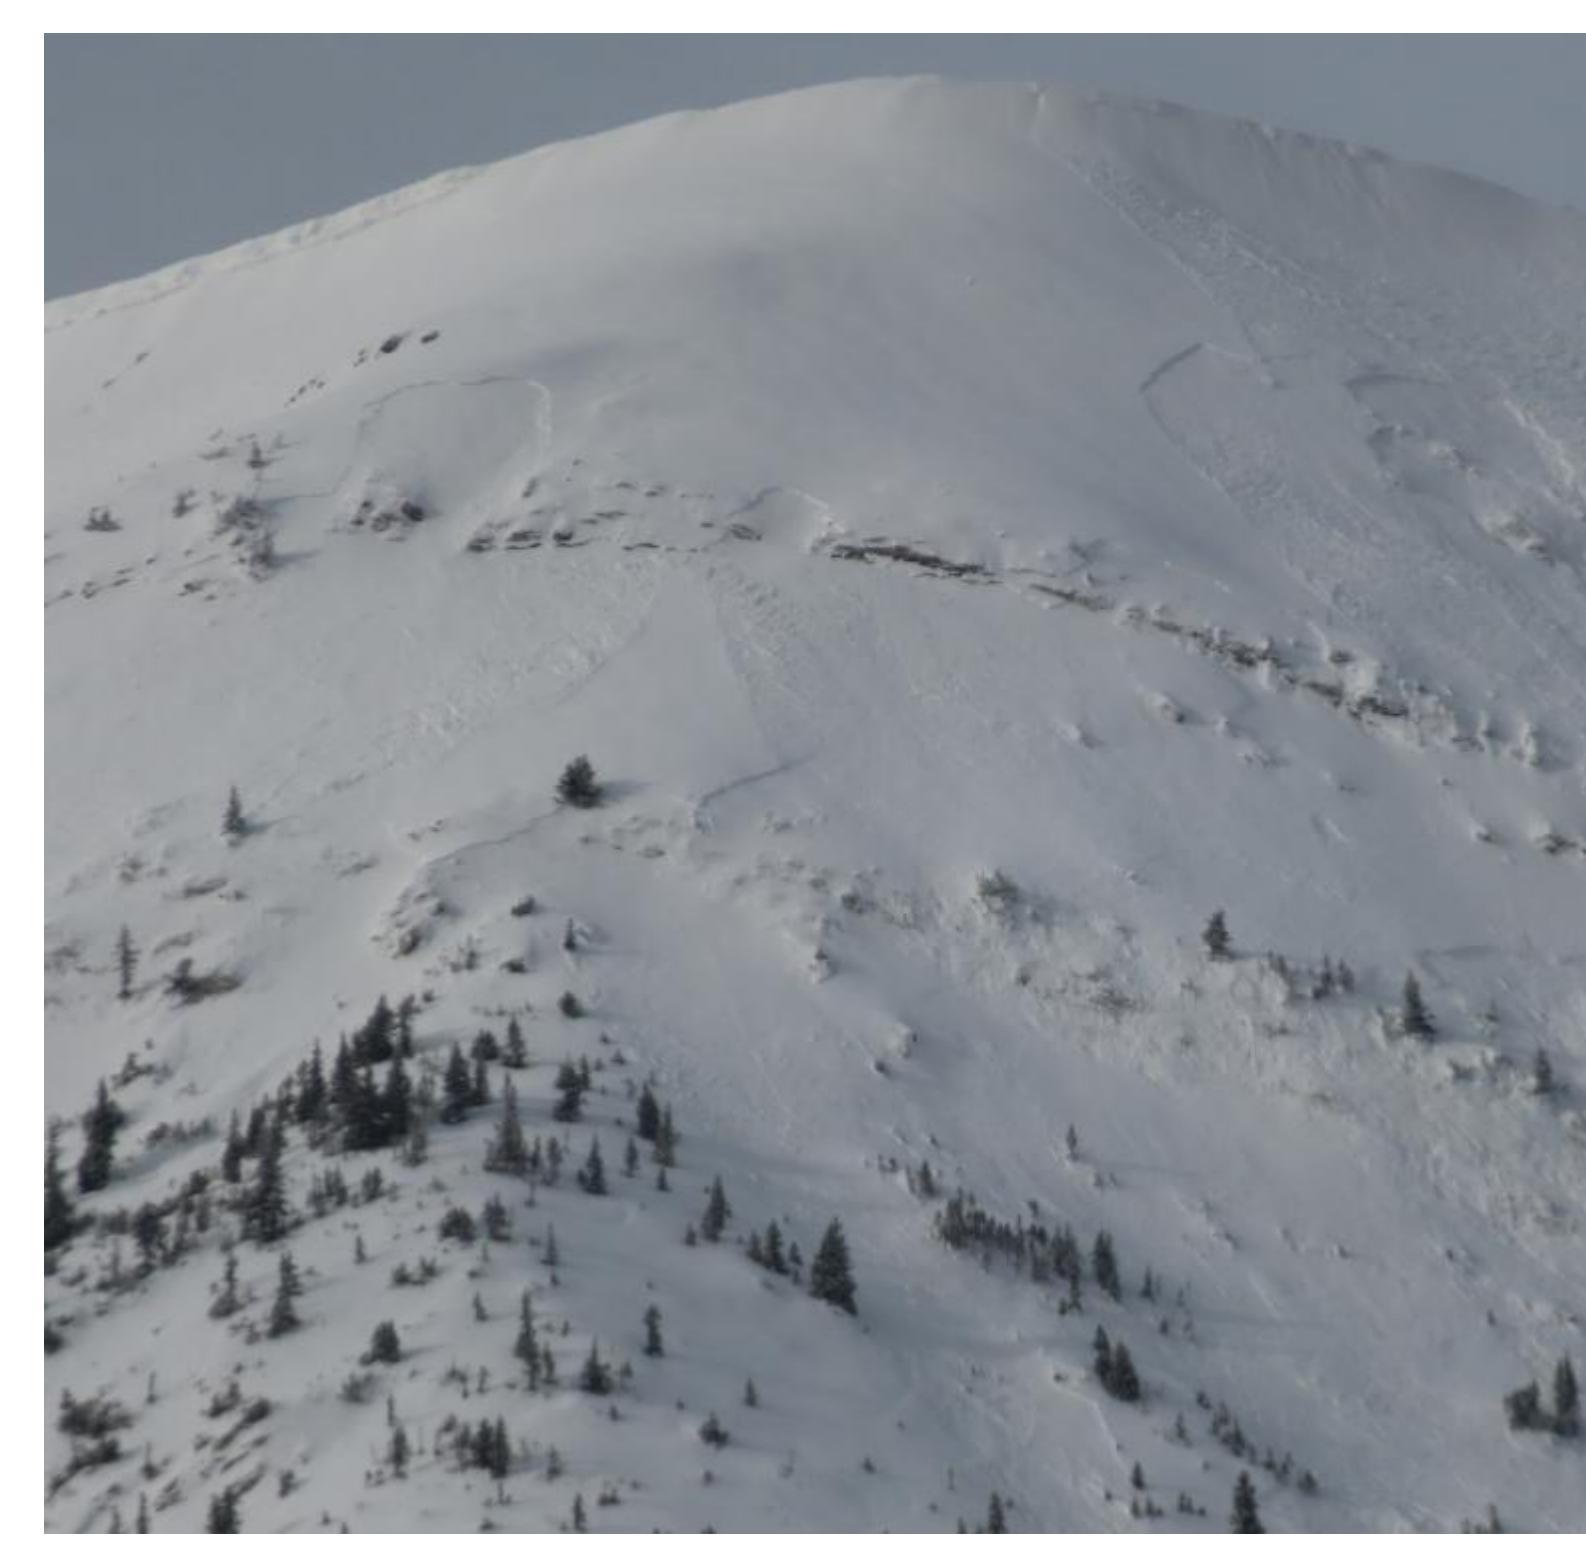
These avalanches were reported yesterday 12/15 by ski patrol who heard them run and saw debris around 1230. They broke naturally towards the end of a period of heavy snowfall that totaled 10"=1.22" SWE. Photos taken 12/16 at 1045-1100. Photo: GNFAC
